PRELIMINARY ASSESSMENT

**Durango Lead Smelter
Durango, Colorado**

CERCLIS ID #CO0001399633

**URS Operating Services, Inc.
1099 18th Street, Suite 710
Denver, CO 80202-1908**

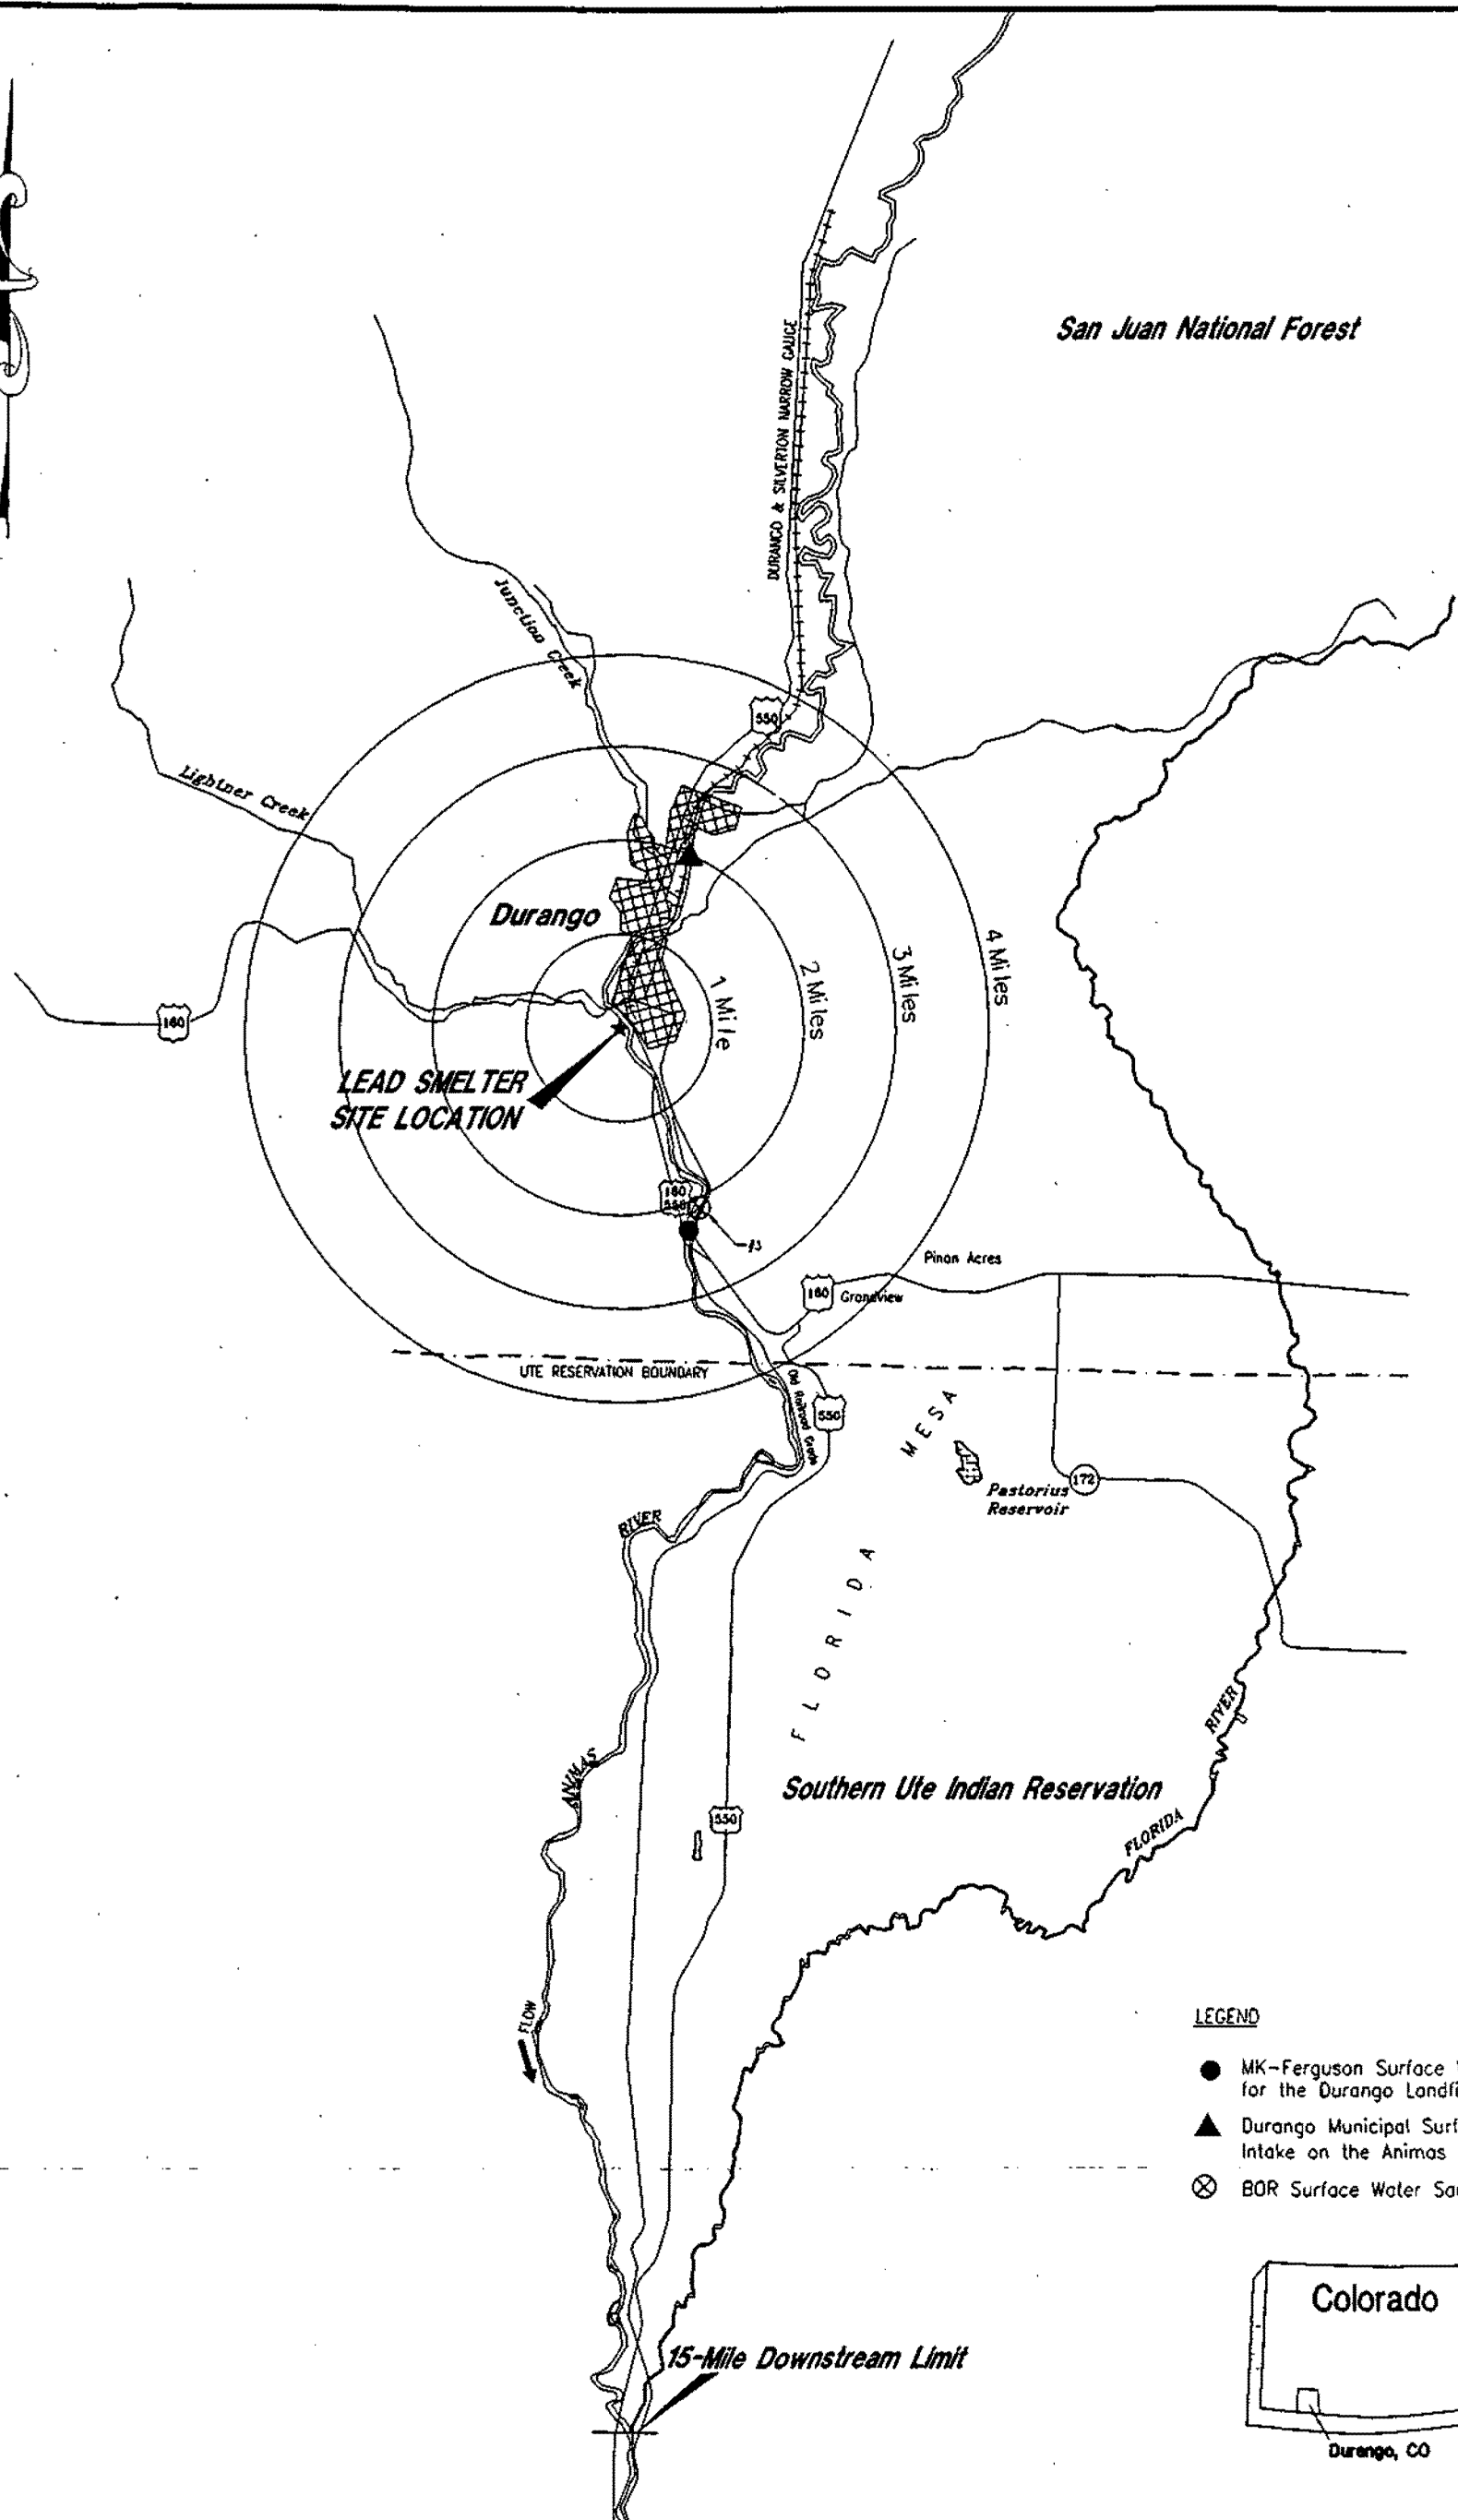
Area of Influence Map
Figure 1

- LEGEND**
- MK-Ferguson Surface Water Sample for the Durango Landfill SIP
 - ▲ Durango Municipal Surface Water Intake on the Animas River
 - ⊗ BOR Surface Water Sample

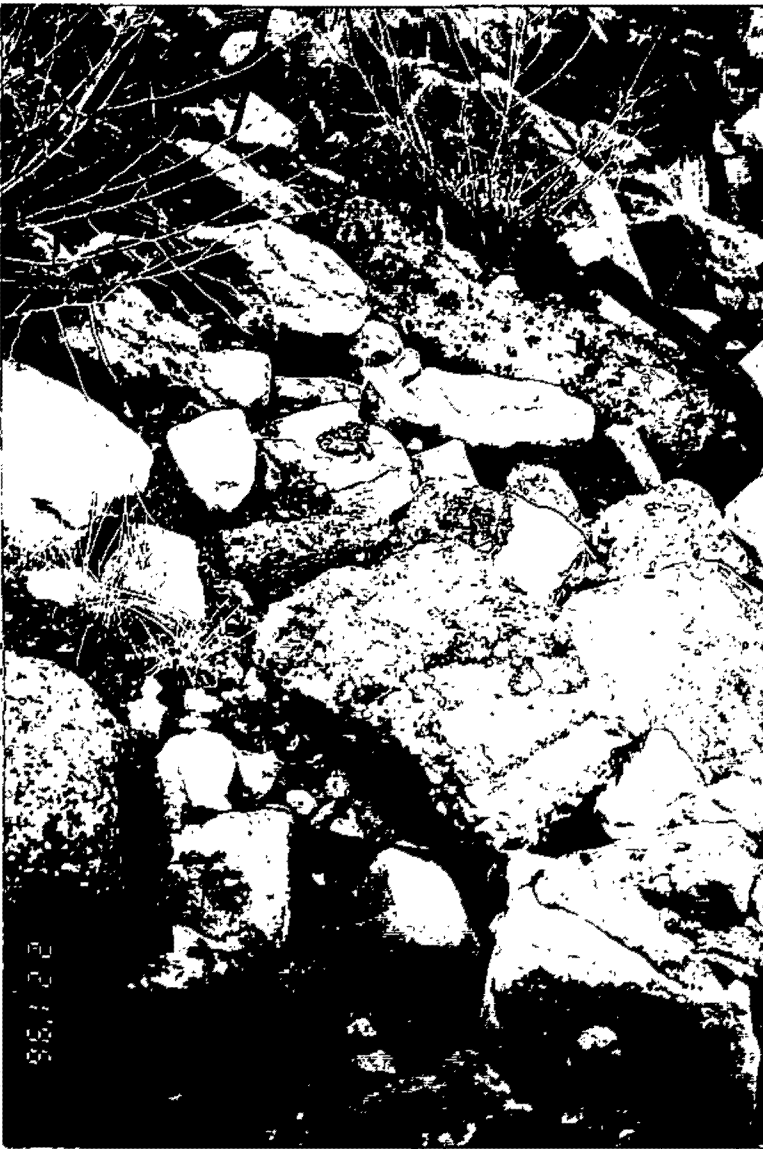
PHOTO 1

Photo of the west bank of the Animas River showing slag chunks, foundation material, and metal debris intermixed with riprap material.

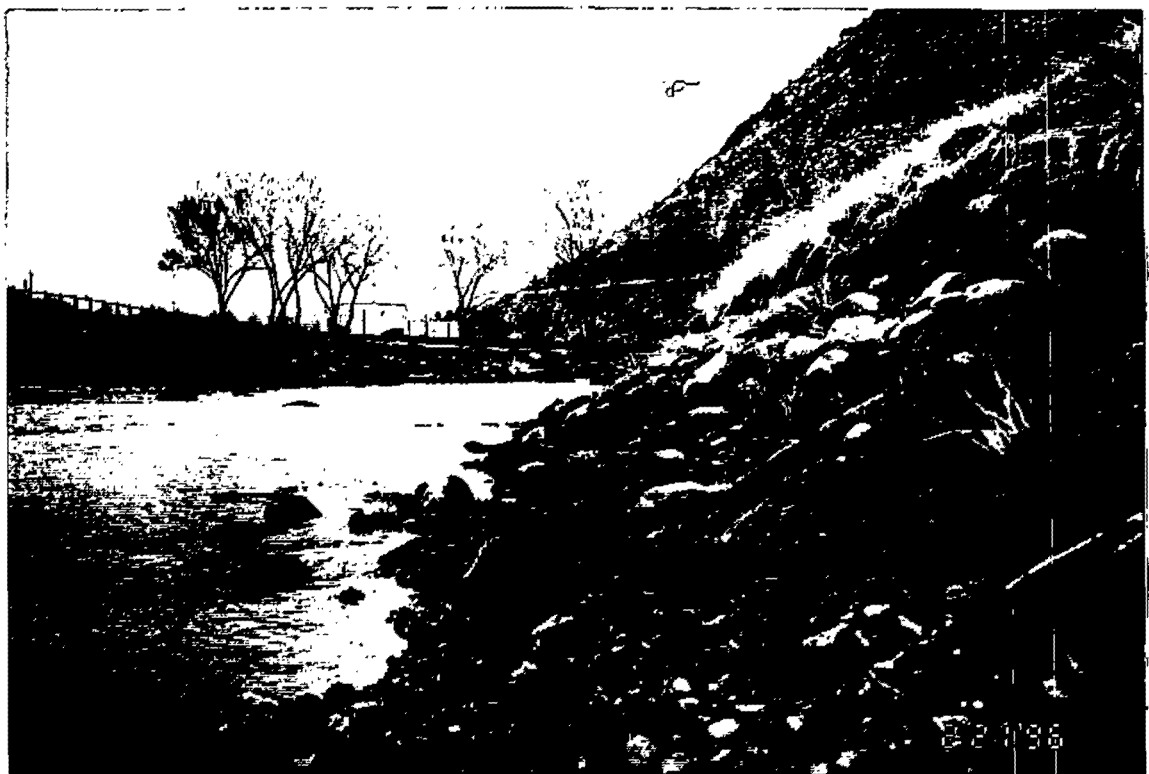
PHOTO 4

Overland Flow/Surface Water Runoff: Site is located on west bank of Animas River. Slag was observed to be sloughing into the river.

View to the south of the west bank of the Animas River. Note slag material sloughing into the river.

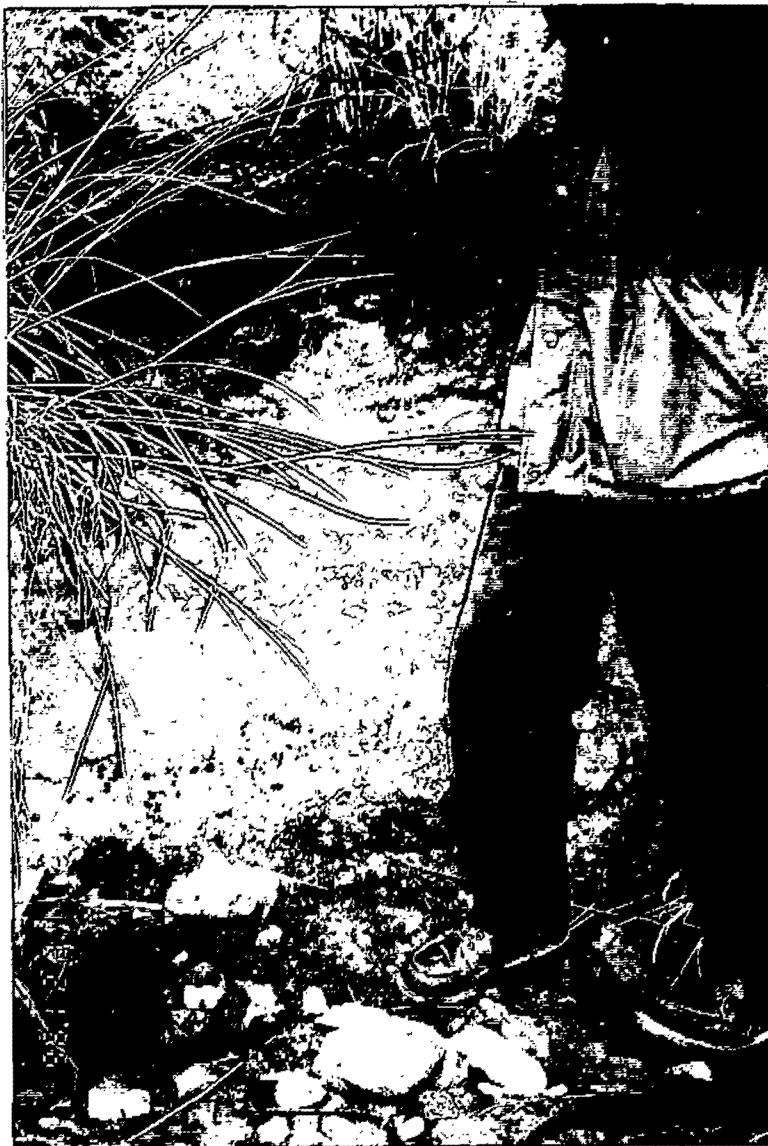
PHOTO 5

Photo of the eroding bank (facing west). Note slag chunks embedded in the bank near the high water mark.

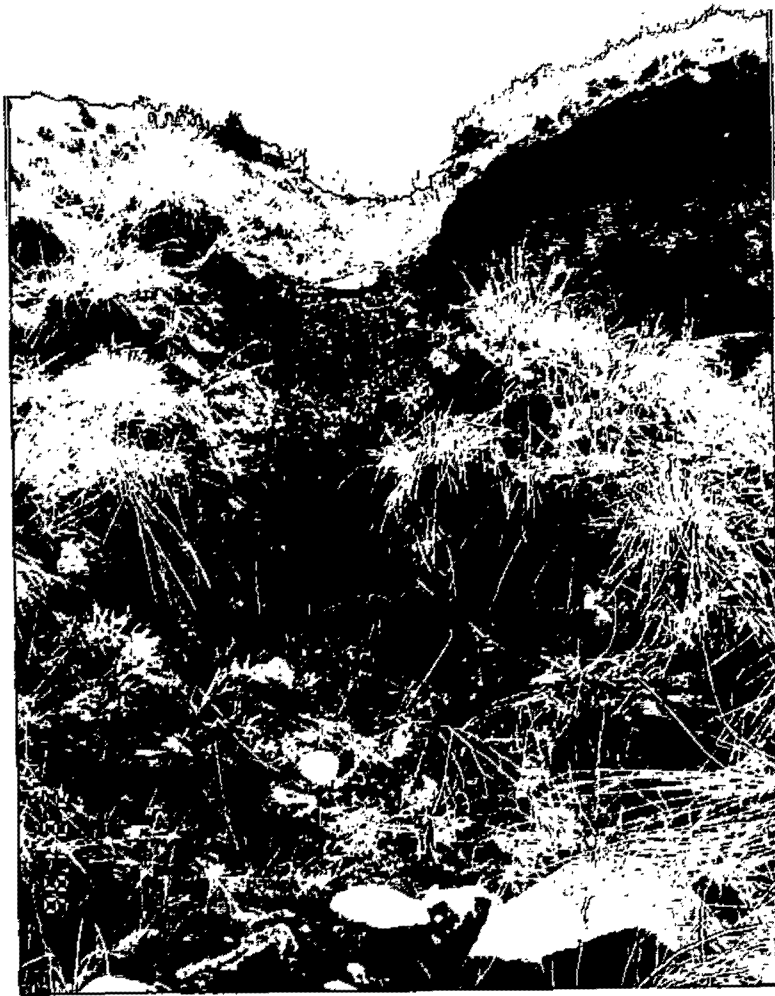
PHOTO 6

View facing west of a drainage channel to the Animas River. Slag outcroppings line the channel.

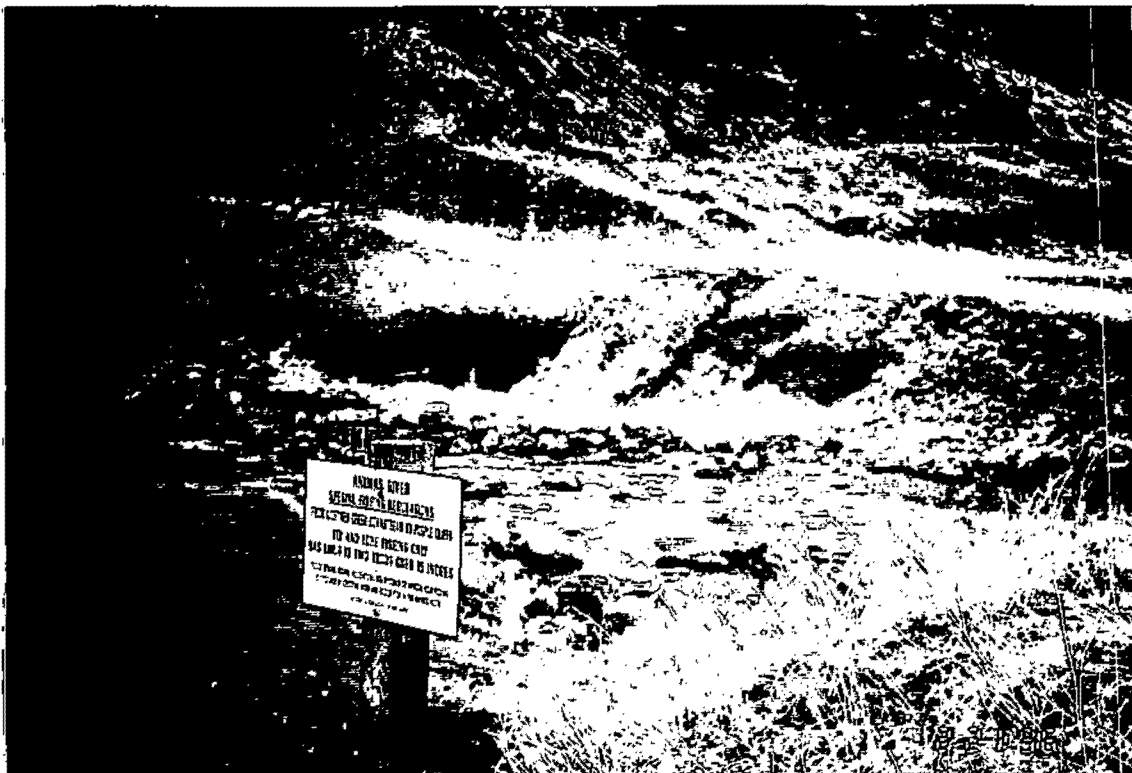
PHOTO 7

Taken to the southwest, this photo shows the Animas River Special Fishing Regulations posting with the river in the background. Note the slag outcropping in the left frame.
